Product Case History

Mamquam Generating Station

The Mamquam Hydro-Electric 56 MW Facility was built in 1996. It is based on using a bored power tunnel with a 434m steel tunnel liner just preceding the power house. The tunnel liner is 2.1 M (7Ft) in diameter and is 434m (1424Ft) long. The tunnel liner was not coated before initial installation, and due to extreme moisture and humidity levels the steel suffered severe pitting and corrosion along the entire length. The owner, Atlantic Power, decided to have the exterior of the tunnel liner prepared and coated to help preserve the liner and to increase its service life.

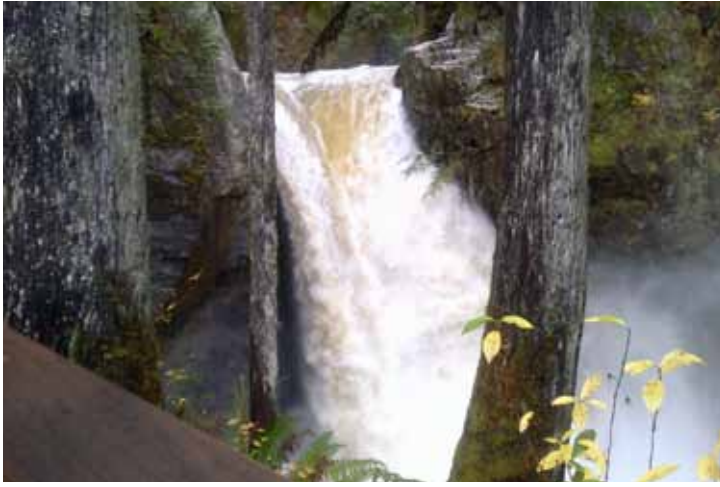
Carboline came to the rescue. This was a very challenging project to come up with a coating system due to the excessive moisture and humidity that is present 365 days a year in this environment. The tunnel liner is located down a vertical shaft and is located directly under a pool and waterfall that allows water to run through the rocks and seep directly onto the steel liner. Small rivers ran under the supported steel liner. A coating system was required that was not only moisture tolerant but also cold temperature curable. The project was completed in February and the water running through the in-service liner was 1°C and the surrounding ambient air was 11°C, well below the dew point.

Waterfall over Vertical Shaft

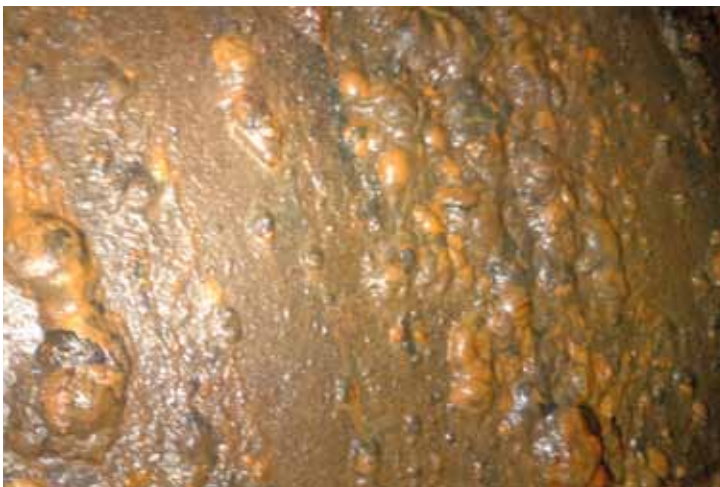
Tunnel Liner - Before Application

The system chosen was Carbomastic 615 MIO Filled Epoxy Primer with Carboguard 690 Epoxy as the top-coat. After an initial power

wash with clean water, the surfaces to be coated were abrasive blasted to SSPC SP10 Near White Metal. This provided the surface profile desired, though due to excess moisture the surface was power washed a second time to remove the residual blast media and rust bloom that was also present. The area was blown down to remove any standing water and each coat was spray applied and back rolled to remove the moisture under the film. Additional attention was given to all of the areas that were pitted to assure proper coverage on edges and in the valleys of the pitting. This process required a grid approach to assure full coverage along the whole length of the liner.

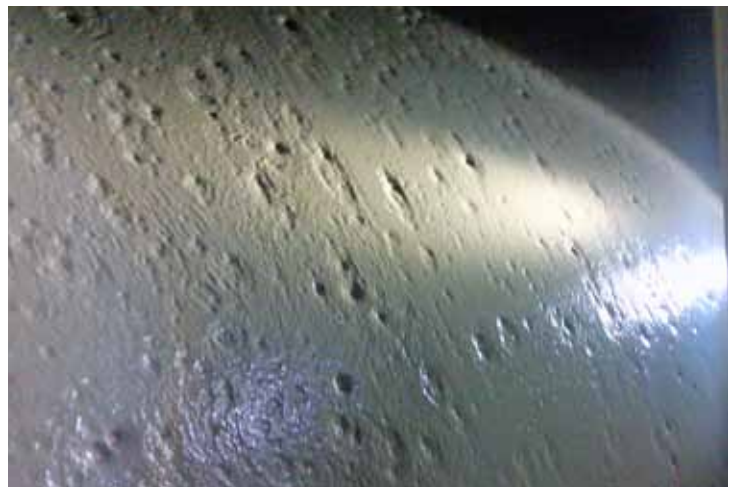
Tunnel Liner - After Application

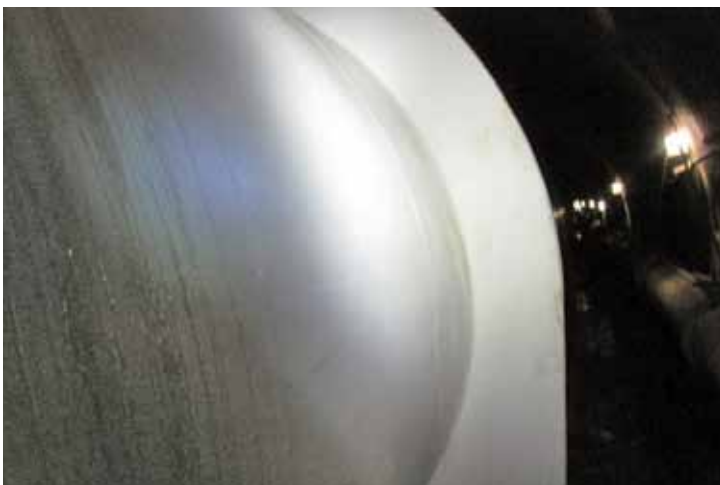
Tunnel Liner - 6 Months After Application

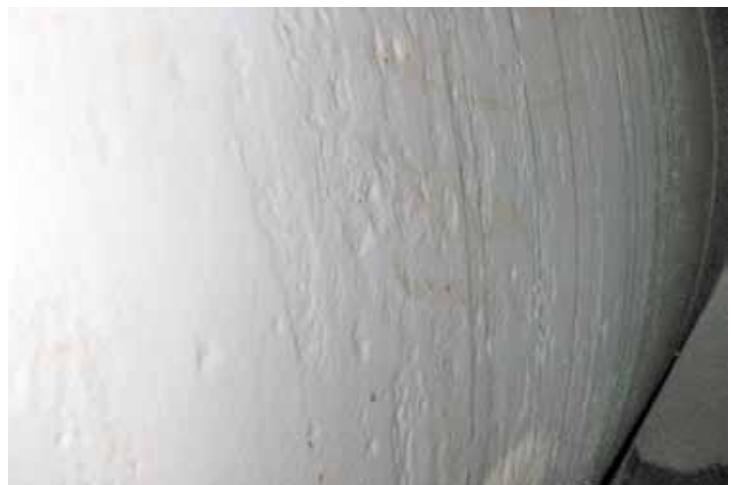
Tunnel Liner - 6 Months After Application
